# Manhole Inspection Summary

## Manhole # S23CC1013MH

Insp Date: **1/29/07 3:04 PM**

**Location** Address: **1425 37TH ST**

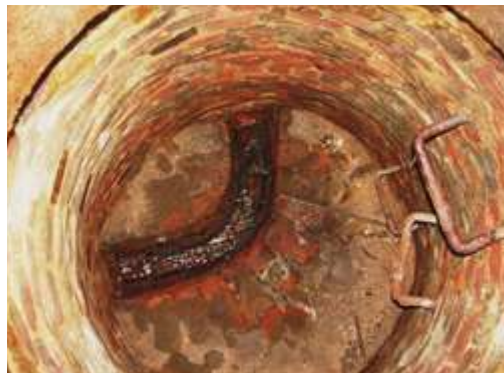
Top View

Frame leaks. Corroded steps. Bench debris. Adjustment infiltration.

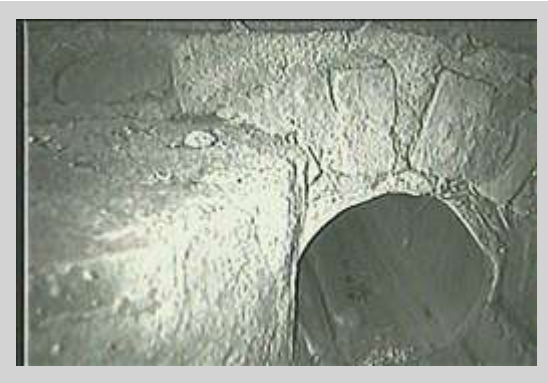
### 8 in. Circular Gravity Sewer Pipe Out @ 12 O'Clock

Infiltration: **Evidence** Pipe Seal Cond: **Cracked**

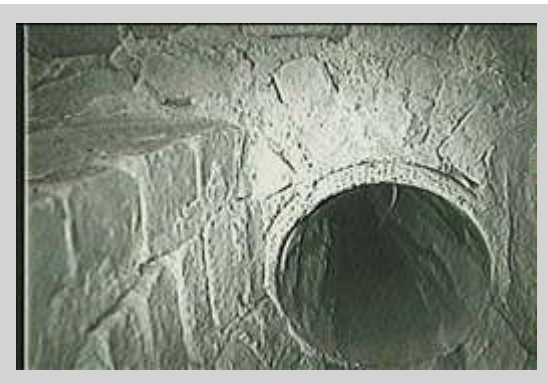
### 8 in. Circular Gravity Sewer Pipe In @ 9 O'Clock

Channel deterioration.

Infiltration: **None** Pipe Seal Cond: **Cracked**
